Modern Reinforcement Methods for Brick Building Repair

Abstract: The article examines the causes of defects and damage identified as a result of research of brick buildings, as well as modern methods of their reinforcement. The disadvantages of traditional reinforcement methods and the advantages of reinforcement with carbon fiber composite material are also highlighted.

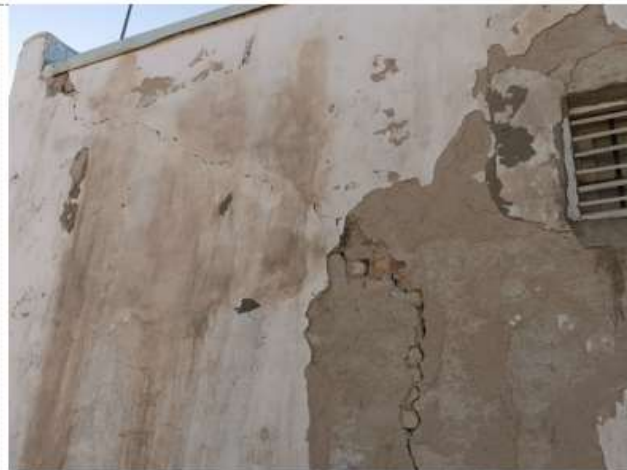
Picture 1. Cracks in the walls as a result of uneven building sinking

- Absence or improper execution of otmoska around the building;
- water accumulation in the basement due to a malfunction of the communication system;
- cracks in the walls as a result of uneven subsidence of the building, see Figure 1;
- humidity in the basement of the building due to poor quality of horizontal and vertical waterproofing, see Figure 2;
- moisture in the top floor walls and roof covering due to failure of the roof waterproofing layer, see Figure 3;
- damage to the brick and mix under the influence of temperature due to moisture in the wall, see Figure 4;
- The thickness of the seams in the brickwork exceeds the requirements of the QMQ.

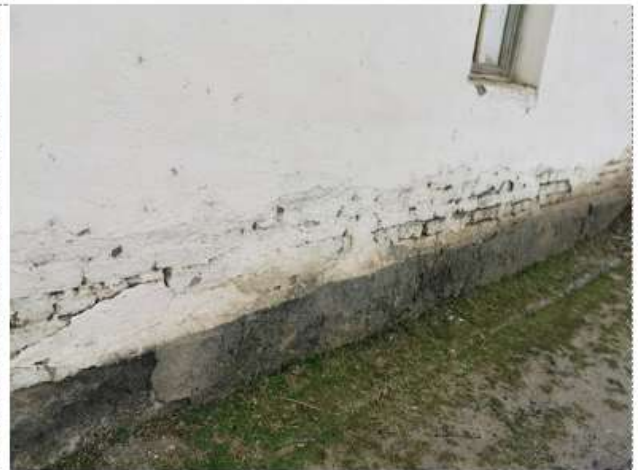
Picture 2. Moistness of the building's foundation and basement

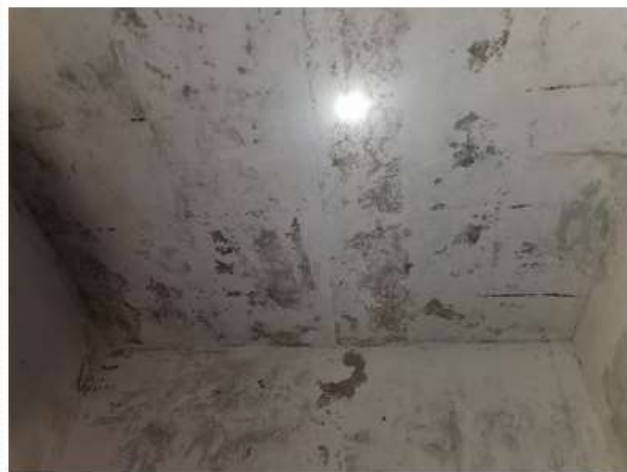
Picture 3. Moistness of the reinforced concrete slab and walls.

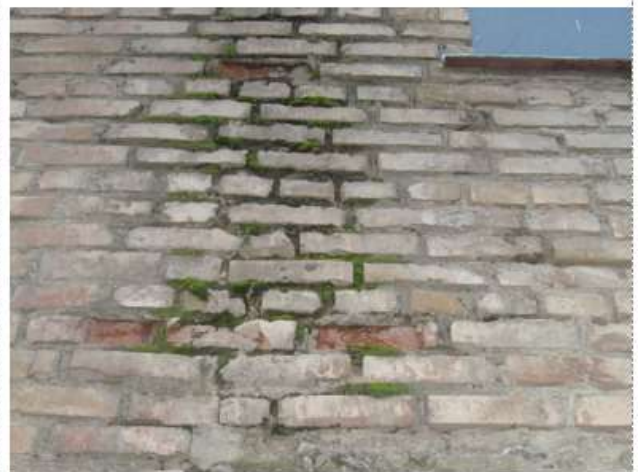
Picture 4. Damages of moisturized brick and mixture under the influence of temperature
