Deficiencies and Damages in Used Brick Buildings

Abstract: *This article examines the causes of defects and damages in brick buildings which used at present time and their impact on the safety of building structures.*

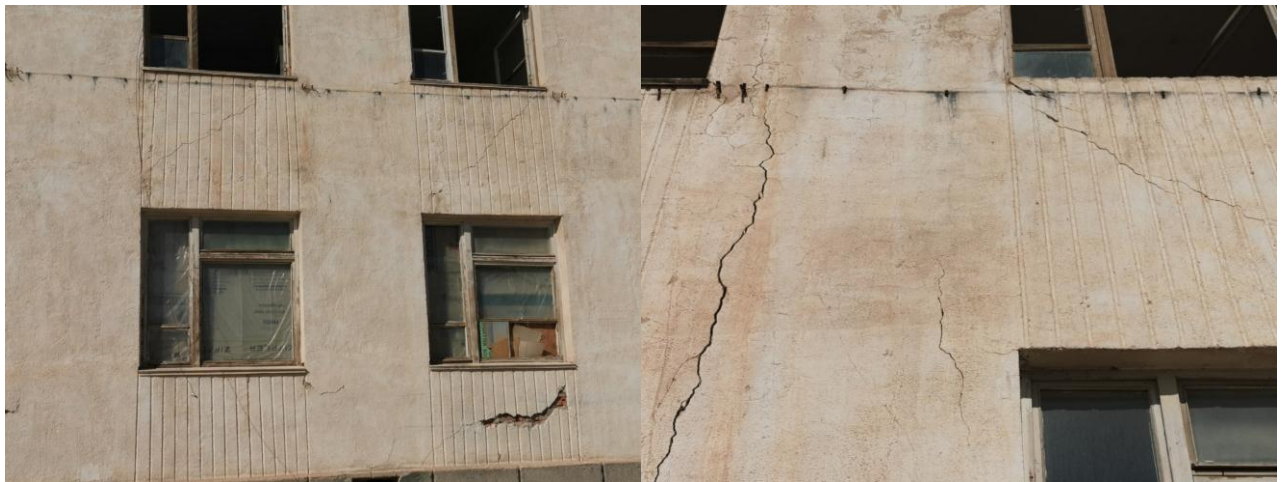
As can be seen from the pictures, as a result of uneven deformation of the base of the building, cracks up to 3 m long and up to 20 mm thick appeared in the outer walls of the building (see pic. 1 and 2). Another reason for this is that there is no anti-seismic belt in the building.

Picture 1. Cracks formed in the outer wall as a result of uneven deformation of the building.

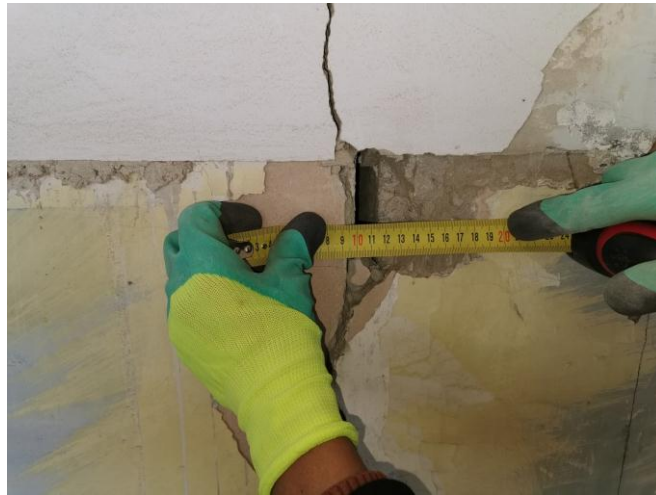
Picture 2. Measurement of the width of the cracks formed in the outer wall as a result of uneven deformation of the building.

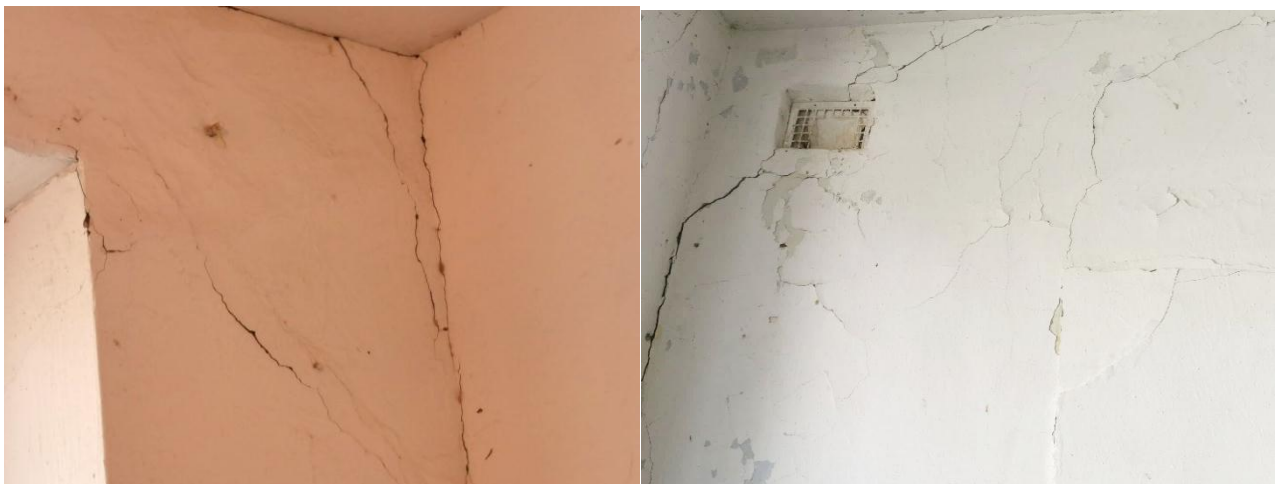
Figure 3. The outer and inner walls are cracks formed at the junction node.

As a result of uneven deformation of the base, cracks were formed at the junction of the outer and inner walls (see picture 3). Errors and defects during the construction process also influence to the appearance of these cracks. For instance, bricklaying, at the junction nod was done incorrectly, and in the process of bricklaying wire nets were not installed.
